RESTAURATION CATALOG

LADIES' SALON

MUSEUM
WILLET-
HOLTHUYSEN

RESTORATION OF THE LADIES' SALON

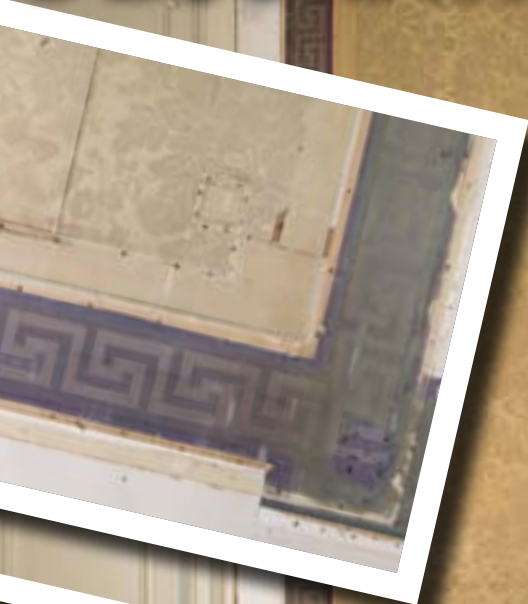
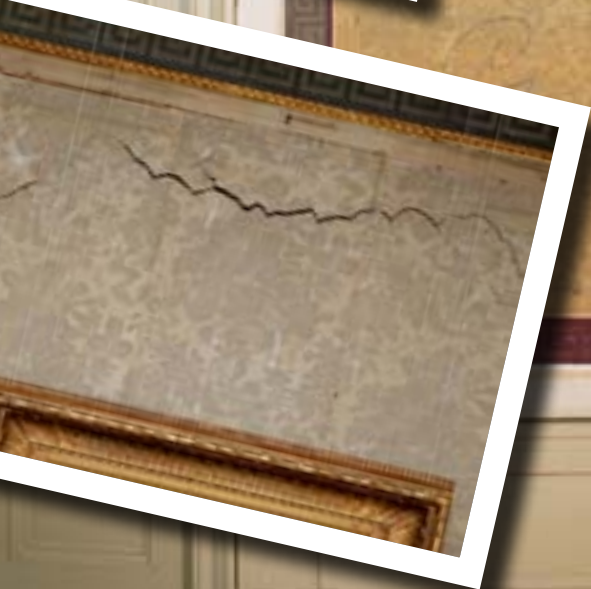
WALLPAPER & DECORATIVE FRAMES

The salon walls are decorated with velouté wallpaper in the room's theme colours: yellow, purple and silver-grey. Velouté imitates textile and is made using a method that was widely employed in the 19th century. A layer of glue is applied to the paper in a pattern - here it is a floral design. Over this, fine particles of wool are scattered, leaving a textile relief in the desired form.

Four of the five walls still have the original wallpaper. On two of these, the paper was exposed in 1996. On the other two walls, restorers plan to remove the modern covering. The tears and patches that have accumulated over the years will be treated so that the original 19th paper can be retained. None of this original covering remains on the long wall parallel to the corridor. So a reconstruction will be made to match the - somewhat faded - colours of the wallpaper that once decorated that section.

In most places, the ornamental gilt frame and rosettes bordering the wallpaper has disappeared. These are known as baguettes, and with the coiled ribbon frames they divide the walls into sections and at the same time hide the joins where the sheets of paper meet. With their shiny gilt finish, the reconstructed frames will play a key part in returning the room to its former grandeur.

Name:	Wallpaper and frames
Material:	Paper, gilt woodcarving
Colour:	Yellow, purple, silver-grey, gold
Condition:	Tears in wallpaper, missing frames

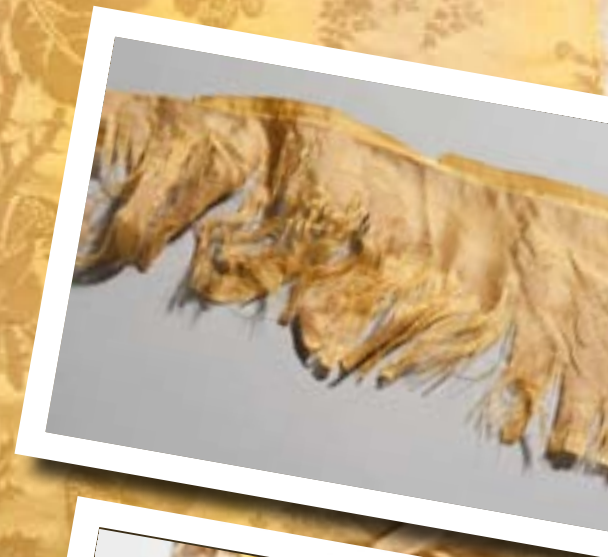
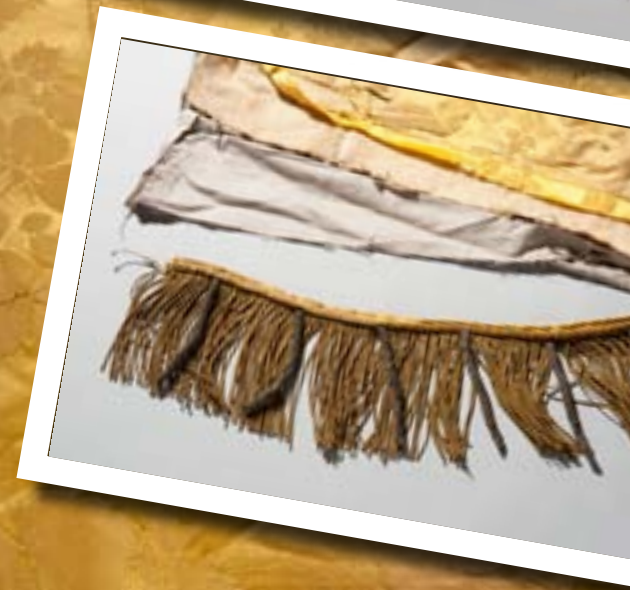
DRAPERY

The curtains in the salon are of yellow silk damask with a floral pattern, trimmed with a decorative band and a fringe. Sunlight, wear and dust have taken their toll on the original curtains, so that these can no longer be used. To restore the ambience created by the original drapery, new curtains will be made, based on the 19th-century example.

Since the valances suffered less exposure to sunlight, these are still perfectly useable. The salon's net curtains and blinds have not survived. Replacements are being made based on similar shades that have been preserved in other fashionable interiors of the time.

Name:	Drapery and accessories
Material:	Silk damask, fringe, cords and tassels
Colour:	Yellow
Condition:	Worn, torn, faded

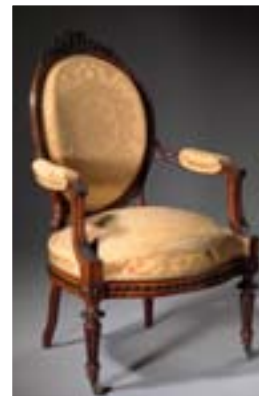
ARMCHAIRS

The two armchairs were originally part of a set of four. Neither have their original upholstery; moreover, the present fabric is rather worn. The restorers will recreate the original cloth and this will be used to upholster the chairs. The body is made of palisander with rosewood veneer and dark stained details, all of which is in good condition on both chairs.

Name:	Two armchairs
Material:	Palisander, yellow silk damask, rosewood veneer
Colour:	Yellow, reddish-brown
Condition:	Upholstery no longer original; worn, faded

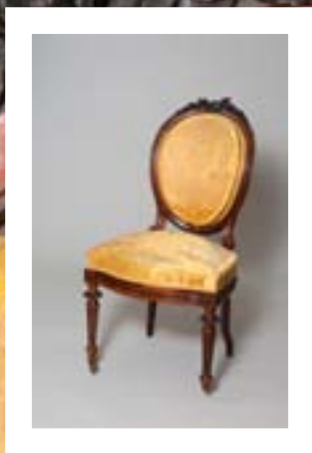
STRAIGHT- BACKED CHAIRS

Of the original set of six chairs that once stood in the salon, two remain. The upholstery on these chairs is no longer original either; moreover it is worn and faded. As on the armchairs, the original upholstery matched the drapery. The recreated yellow silk damask will also be used to cover these chairs. On one of them, the crest on the top rail is damaged and requires restoration.

Name:	Two straight-backed chairs
Material:	Palisander, rosewood veneer, yellow silk damask
Colour:	Yellow, reddish brown
Condition:	Upholstery no longer original, worn, faded, broken crest
